Debris/Ice/TPS Assessment and Integrated Photographic Analysis of Shuttle Mission STS-86

**DEBRIS/ICE/TPS ASSESSMENT
AND
INTEGRATED PHOTOGRAPHIC ANALYSIS
OF
SHUTTLE MISSION STS-86**

25 September 1997

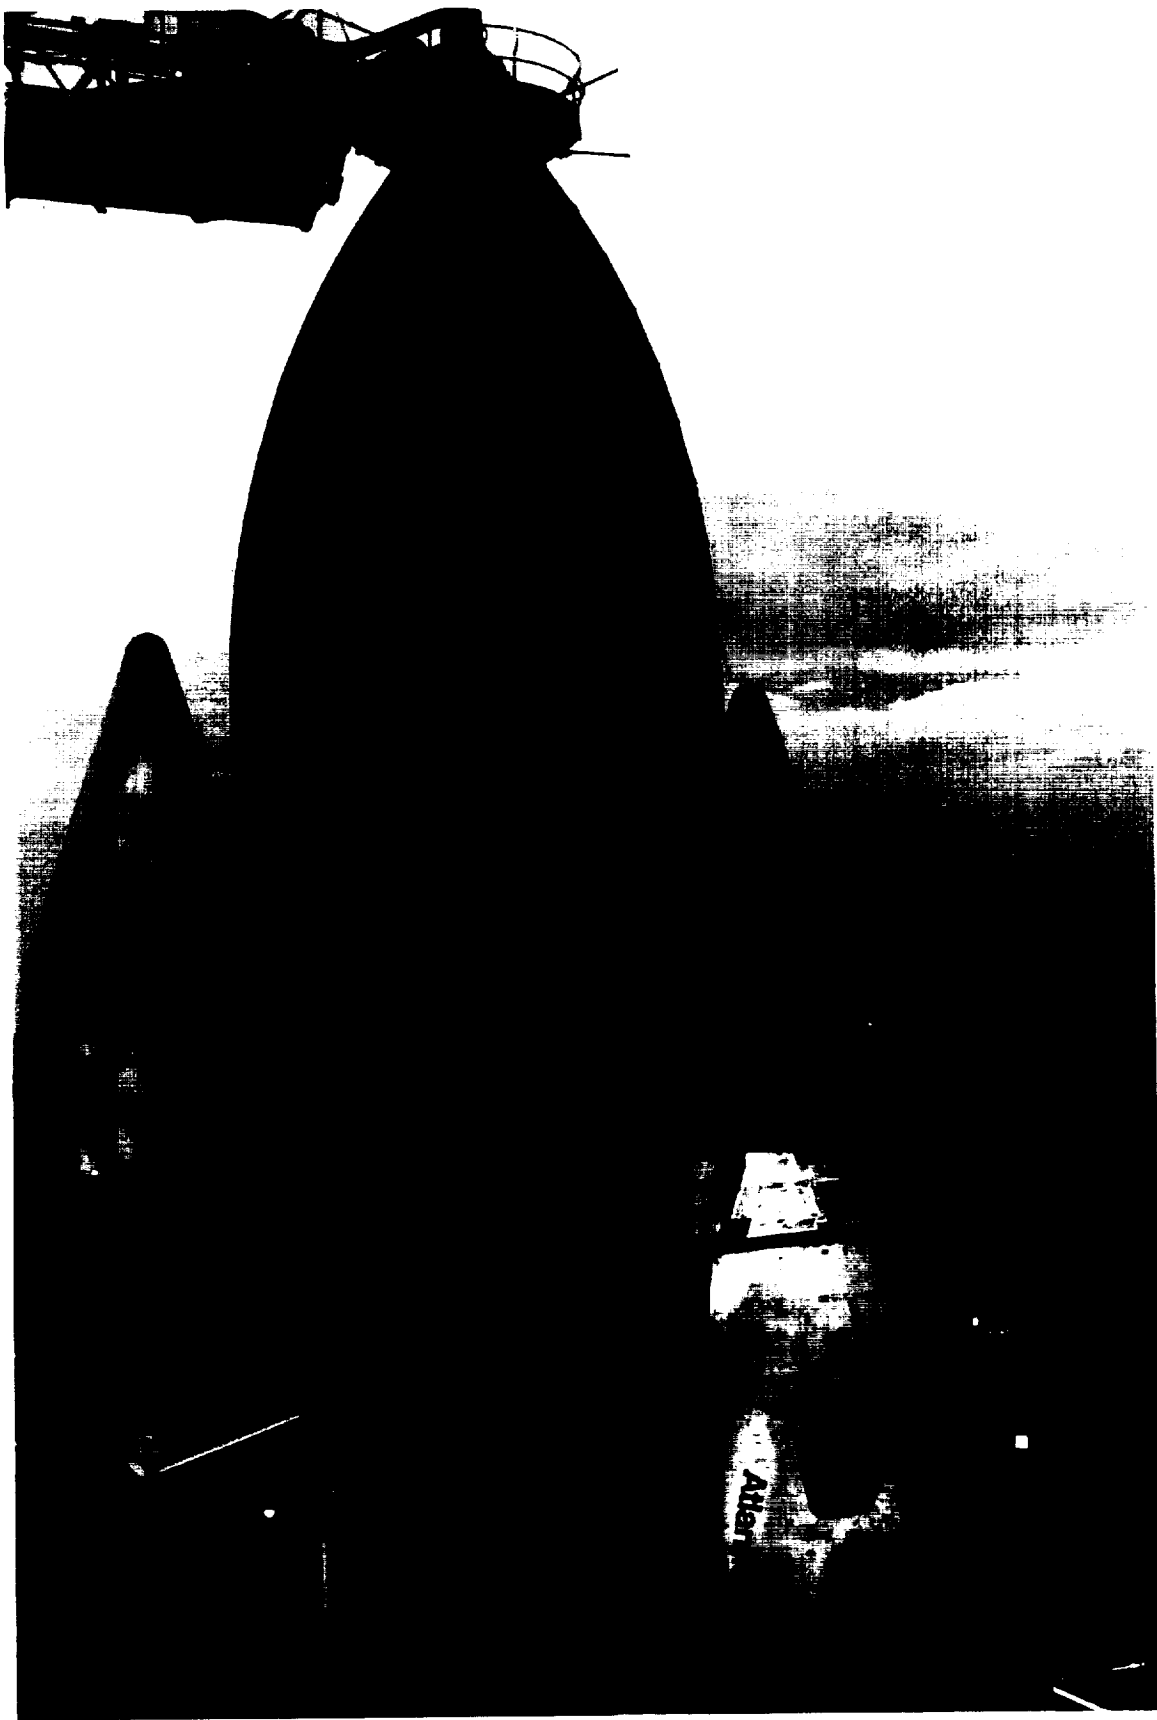
Photo 2: STS-86 Ready for Launch

OV-104 Atlantis (20th flight), ET-88 (LWT 81), and BI-090 SRB's. The Final Inspection Team observed light condensate, but no ice or frost accumulations, on the LO2 tank acreage. TPS surface temperatures averaged 71 degrees F.

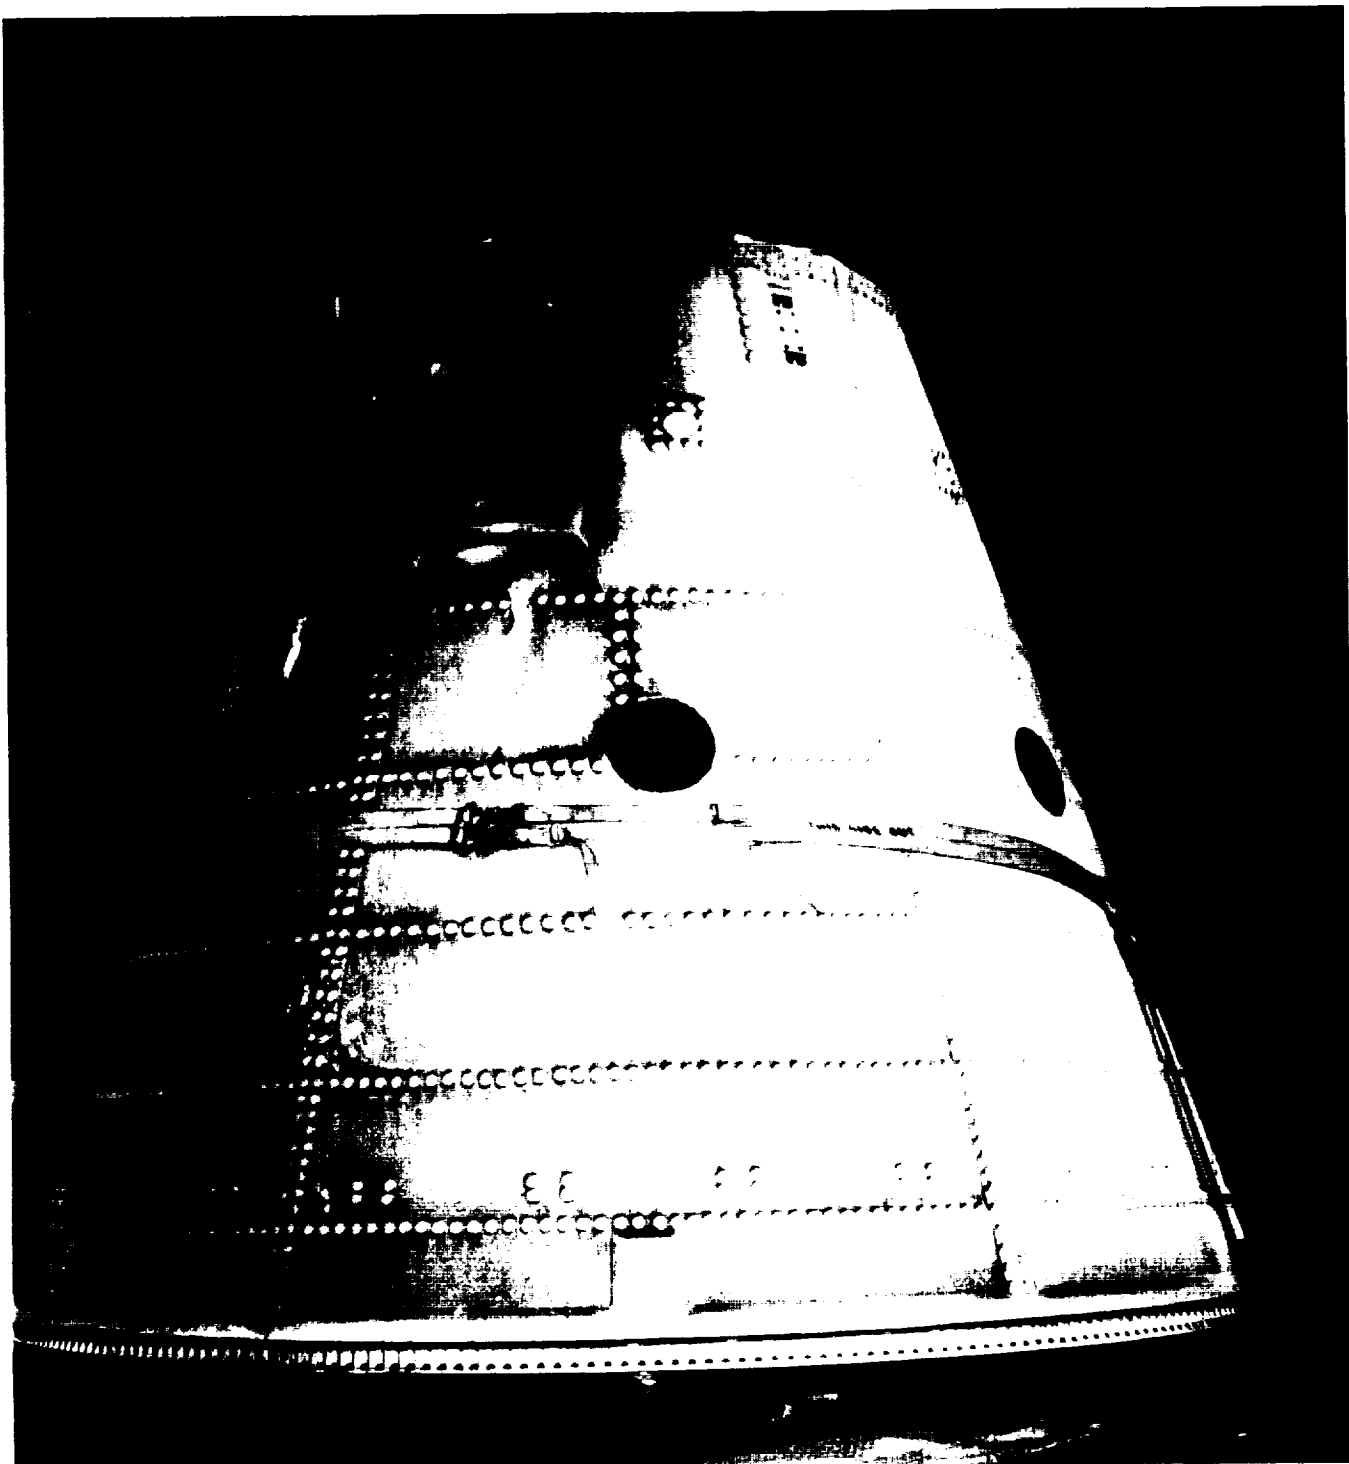
Photo 10: Frustum Post Flight Condition

Both frustums were in excellent condition. No TPS was missing and no debonds/unbonds were detected over fasteners. Virtually none of the Hypalon paint had blistered. All eight BSM aero heat shield covers had locked in the fully opened position though the attach ring on the left frustum upper left position had been bent by parachute riser entanglement.

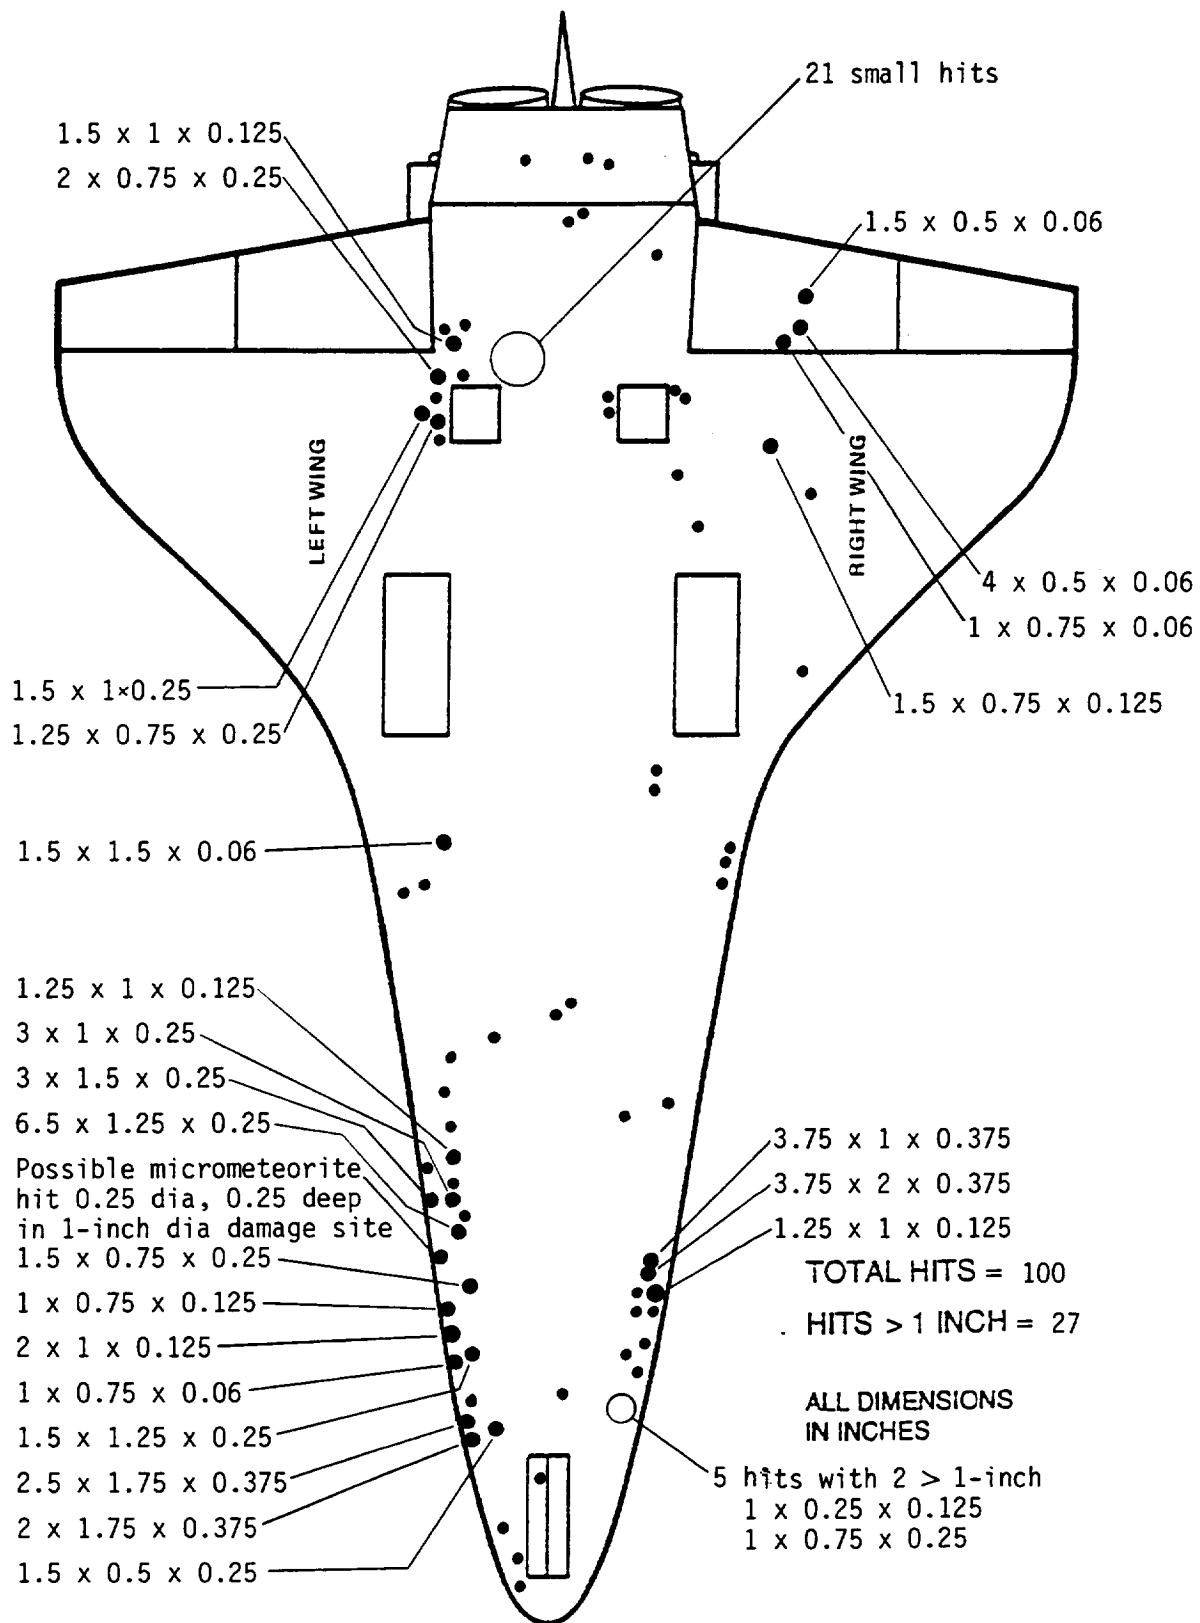
Figure 1: Orbiter Lower Surface Debris Damage Map

The Orbiter lower surface sustained a total of 100 hits, of which 27 had a major dimension of 1-inch or larger. The largest lower surface tile damage site was located on the left glove and measured 6.5-inches long by 1.25-inches wide by 0.25-inches maximum depth. This damage site was just one of 26 hits (with 13 larger than 1-inch) from an area to the left of the nose progressing aft almost to the left main landing gear door - an unusual occurrence. In order to investigate the cause of this damage, the ET/ORB umbilical films were reviewed, samples were taken from five tile damage sites for chemical analysis, and the data base for debris particles in an aerodynamic flow were utilized for trajectory analysis.

The trajectory analysis considered a variety of debris particle sizes, densities, and Mach numbers. The results indicated the tile damaging debris most likely originated from an area equivalent to the ET intertank, LO2 tank barrel section, or left SRB nose cap (the left SRB frustum was missing no material when inspected after flight). The Orbiter umbilical films yielded no information due to the dark conditions of a night launch. The tile damage sites were scoured clean by re-entry and samples taken for chemical analysis yielded no definitive traces. Therefore, the cause of the unusual tile damage is unexplained, though it should be noted the new ET composite nose cone is located too far forward on the vehicle to be considered a probable source.

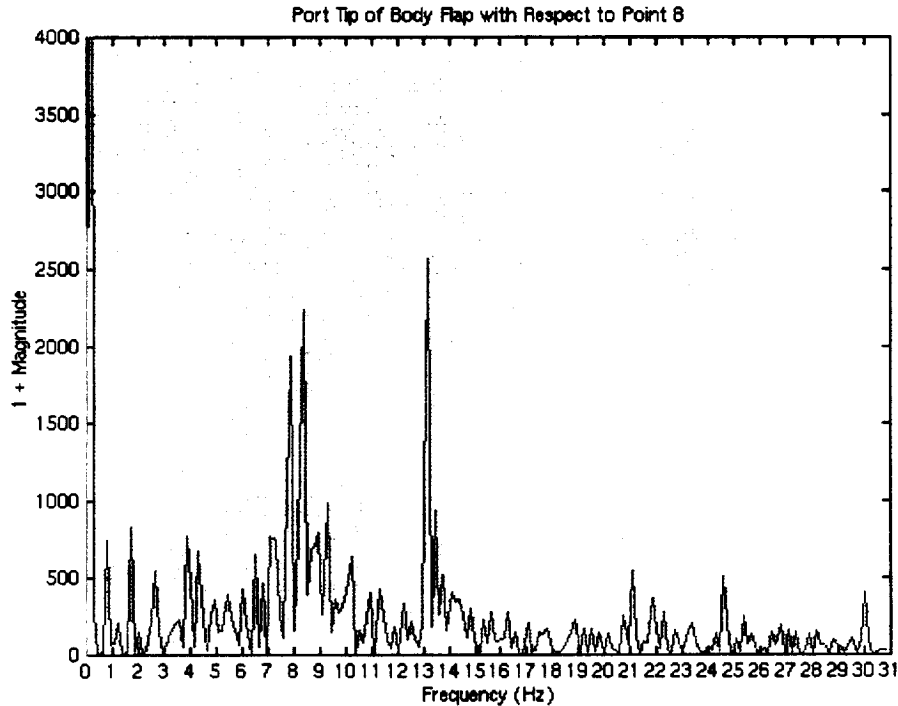
Figure 2.4.2 (B) Frequency Plot of STS-86 Body Flap Motion (Port Tip)

inches. The maximum peak-to-peak deflection measured approximately 4 inches on both the port and starboard tips of the body flap. Both the port and starboard data revealed frequency peaks at 8 Hz (global rotation) and 13 Hz (torsion rotation).

Measurements of the body flap motion were also made on STS-84 imagery using identical procedures for comparison to the STS-86 data. The body flap motion seen on STS-84 was similar to STS-86 in frequency except that the 13 Hz frequency peak seen on STS-86 was not evident on STS-84 (torsion rotation). Both the port and starboard data revealed frequency peaks at 8 Hertz (global). On STS-84, an average peak-to-peak deflection of both the port and starboard body flap tips was measured to be approximately 1.9 inches. The maximum peak-to-peak deflection measured approximately 6 to 8 inches on the starboard tip of the body flap and 8 inches on the port side. Table 2.4 is a summary of the body flap motion image measurements from STS-84 and STS-86.
